# INDOOR AIR QUALITY ASSESSMENT

## David Prouty High School 302 Main Street Spencer, Massachusetts

Prepared by:
Massachusetts Department of Public Health
Center for Environmental Health
Emergency Response/Indoor Air Quality Program
June 2005

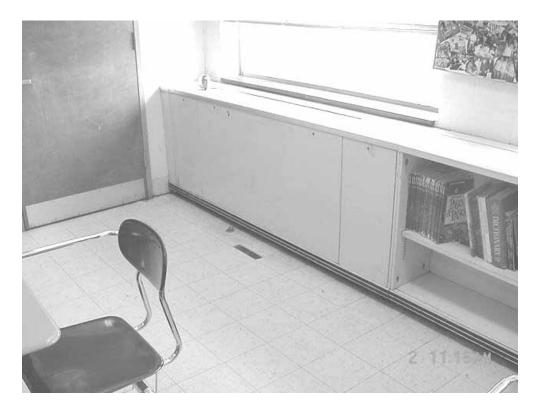
Fresh air in classrooms in the three-story academic wing is supplied by a unit ventilator (univent) system (Picture 1). Univents are designed to draw air from outdoors through a fresh air intake located on the exterior walls of the building (Picture 2) and return air through an air intake located at the base of each unit (Figure 1). Fresh and return air are mixed and filtered, then heated and provided to classrooms through an air diffuser located in the top of the unit.

**Classroom Univent**

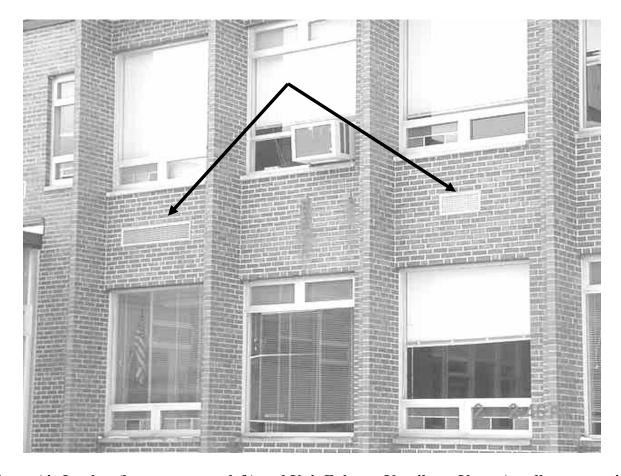
Univent Air Intakes (larger vents on left) and Unit Exhaust Ventilator Vents (small vents on right)

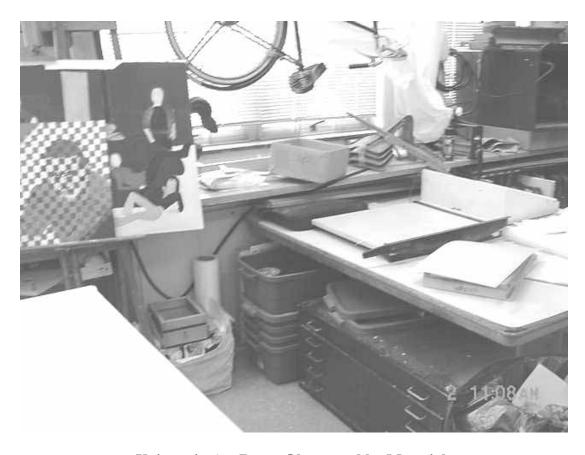
At the time of the assessment, a number of the univents were observed as deactivated, therefore no means of mechanical ventilation was being provided during the assessment. Obstructions to airflow, such as papers and books stored on univents and bookcases, carts and desks in front of univent returns, were seen in a few classrooms (Picture 3). In order for univents to provide fresh air as designed, units must remain activated and allowed to operate while rooms are occupied. Intakes and return vents

Univent in Art Room Obstructed by Materials

- 3. Inspect exhaust motors and belts for proper function. Make repairs as necessary.
- 4. Remove all blockages from univents and exhaust vents to ensure adequate airflow.

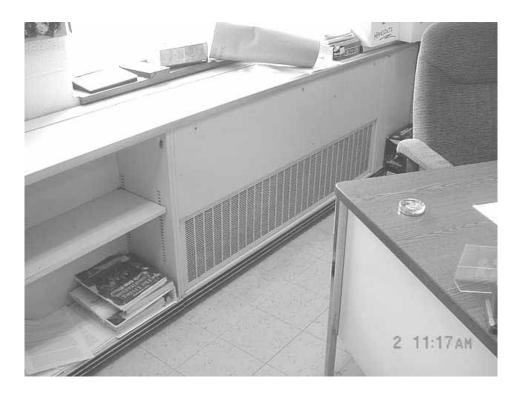
Mechanical exhaust ventilation in the classroom wing is provided by unit exhaust ventilators (Picture 5). A unit exhaust ventilator appears similar to a univent, but removes air from the classroom and exhausts it out of the building (Picture 2). Unit exhaust ventilators were not operating in the majority of the areas surveyed at the time of the assessment. Mechanical exhaust ventilation for classrooms and specialty areas in the single-story wing are provided by grated wall vents powered by rooftop motors (Pictures 6 and 7). Several science classrooms had no exhaust ventilation capabilities (Table 1). Common areas (e.g., auditorium, gymnasium) were designed to be ventilated by air handling units (AHUs). The AHUs in the gymnasium were not operating during the assessment and the wall-mounted return vents were obstructed (Pictures 8 and 9). Without proper supply and exhaust ventilation, normally occurring environmental pollutants can build-up and lead to indoor air quality/comfort complaints, particularly in science classrooms during experiments or demonstrations.

**Unit Exhaust Ventilator**

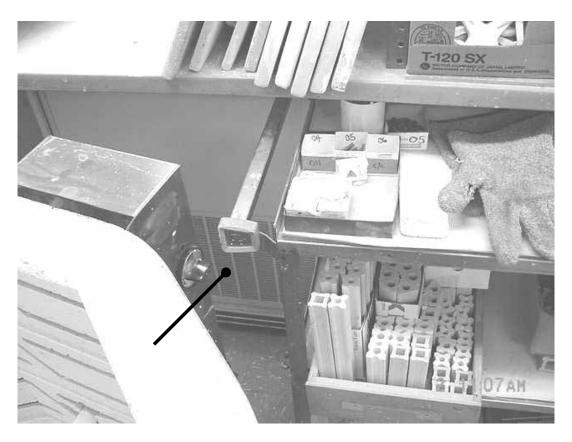
**Unit Exhaust Ventilator Obstructed by Various Items**

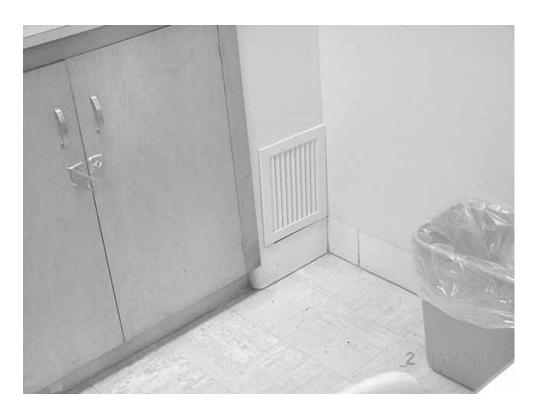
Wall-Mounted Exhaust Vent

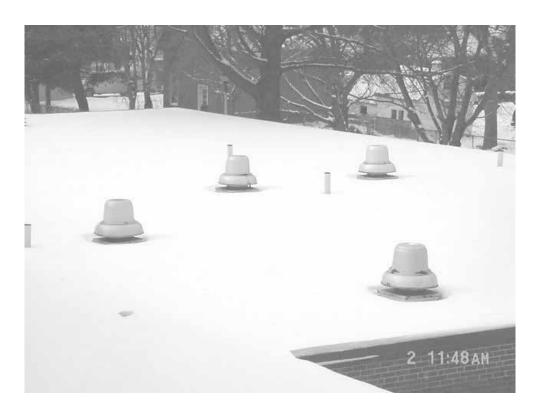
**Rooftop Exhaust Motors**

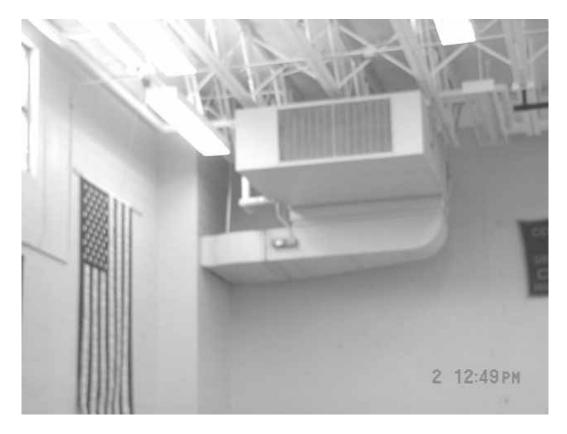
Ceiling-Mounted AHU in Gymnasium

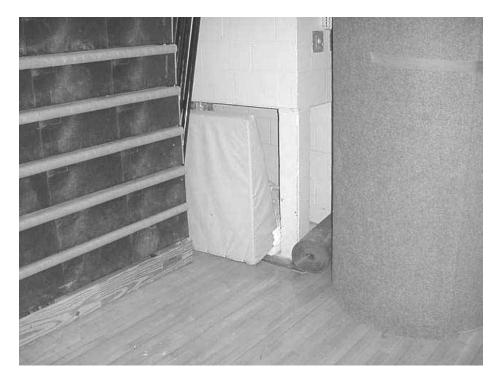
Gymnasium Exhaust/Return Vent Obstructed by Gym Mat

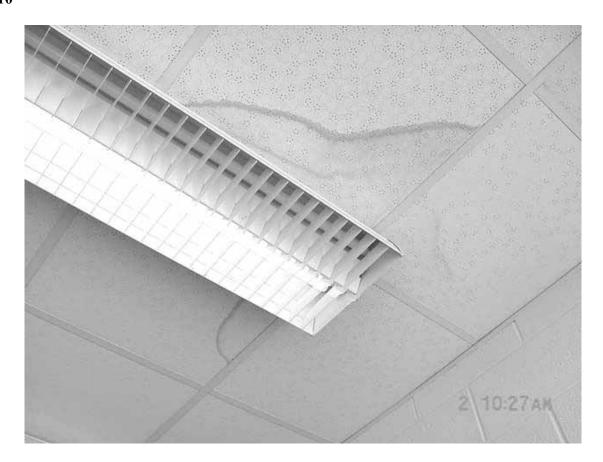
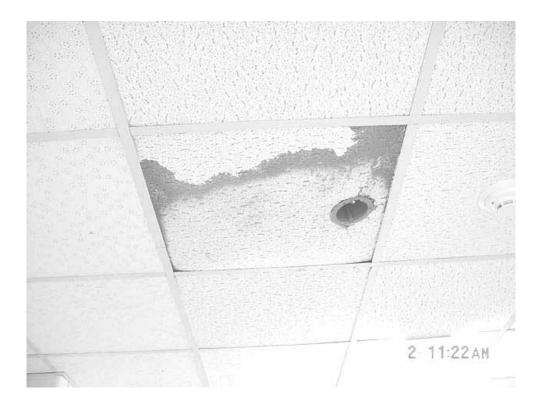
A number of areas had water-stained, missing or damaged ceiling tiles (Table 1/Pictures 10 and 11), which can indicate leaks from the roof or plumbing system.

Active leaks were reported in several areas of the single-story wing. School department officials are reportedly working with a roofing contractor to make repairs. Water-damaged ceiling tiles can provide a source for mold growth and should be replaced after

a water leak is discovered and repaired. Missing and/or damaged tiles can provide a means for dust and particulates that accumulate in the ceiling plenum into occupied areas.

Water Damaged Ceiling Tiles

**Water Damaged Ceiling Tiles**

- 8. Ensure roof leaks are repaired and repair/replace any remaining water-stained, missing or damaged ceiling tiles. Examine areas above these tiles for microbial growth. Disinfect with an appropriate antimicrobial where necessary.

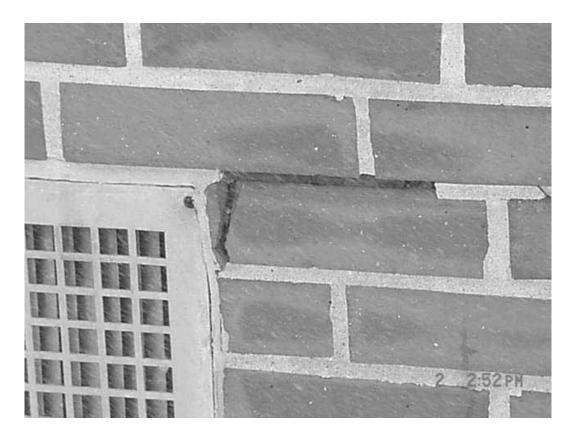
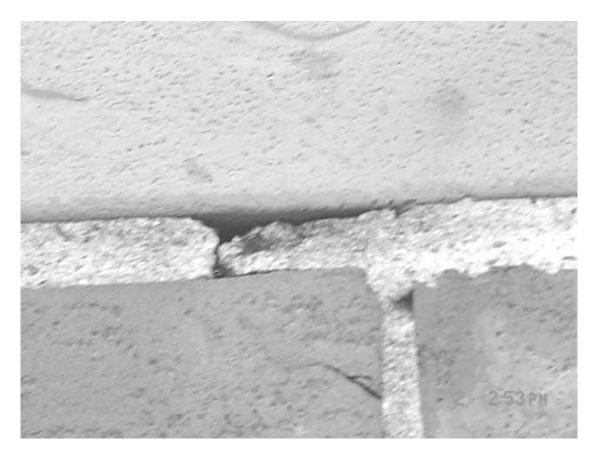
MDPH staff observed several areas where mortar around brick was missing and/or damaged (Pictures 12 and 13). Repeated water penetration can result in the chronic wetting of building materials and potentially lead to microbial growth. In addition, large cracks/holes in the exterior wall may provide a means of egress for pests/rodents into the building.

Missing/Damaged Mortar around Exterior Brick

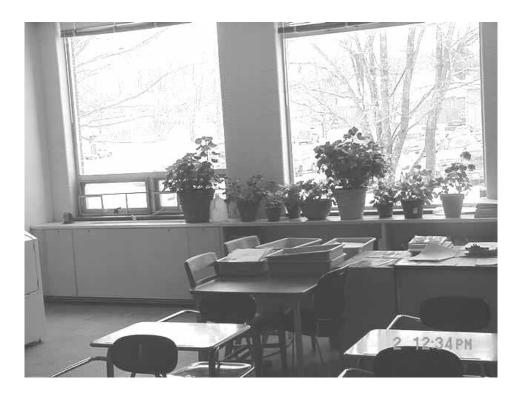
Plants were observed in several classrooms. Plants, soil and drip pans can serve as sources of mold growth. Plants should be properly maintained, over-watering of plants should be avoided and drip pans should be inspected periodically for mold growth. Plants should be located away from ventilation sources to prevent aerosolization/entrainment of dirt, pollen or mold (Picture 14).

Plants in Classroom near Univent Air Diffuser

- Move plants away from univents in classrooms. Avoid over-watering and examine drip pans periodically for mold growth. Disinfect with an appropriate antimicrobial where necessary.

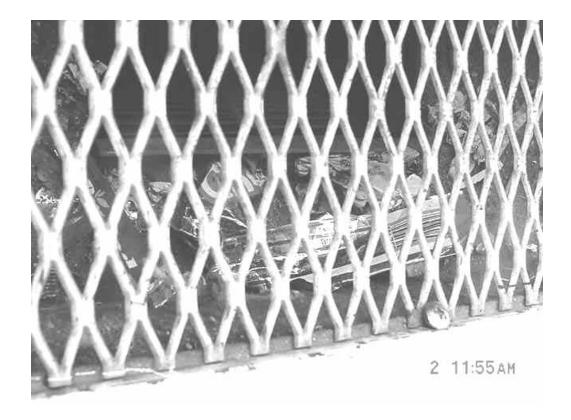
A number of other conditions that can affect indoor air quality were noted during the assessment. Univents in several areas, including the cafeteria, had accumulated dust,

cobwebs and debris within the air handling chambers and on filters. Window-mounted air conditioners (ACs) were installed in several areas. These units are normally equipped with filters, which should be cleaned or changed as per the manufacturer's instructions.

Trash/Debris inside Univent Air Diffuser

- Clean univent interiors, return vents and exhaust vents periodically of accumulated dust.
- 12. Relocate or consider reducing the amount of materials stored in classrooms to allow for more thorough cleaning. Clean items regularly with a wet cloth or sponge to prevent excessive dust build-up.

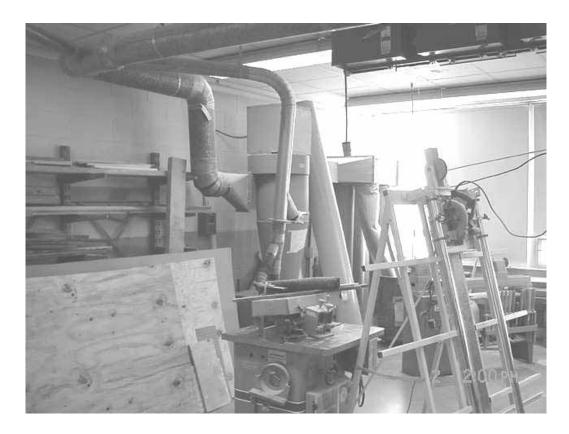
Finally, the wood shop contains a wood dust collection system (Picture 16) indoors. Since the wood dust collector is not designed to filter small diameter particles, the use of this machine without ducting outdoors can aerosolize wood dust to make it more readily inhaled. Wood dust is a fine particulate, which can be easily aerosolized and can be irritating to the eyes, nose, throat and respiratory system.

**Wood Dust Collection System inside Woodshop**

- Consider contacting an HVAC engineering firm to fully evaluate the ventilation systems building-wide. Based on the age, physical condition and availability of parts for ventilation components, this measure is strongly recommended.
- 2. Consider relocating wood dust collection system outdoors or in a shelter separated from occupied areas and ducted to the outside.
